COASTAL BASIN
SALEM-MONTVILLE, CONNECTICUT

BARNES RESERVOIR DAM
CT 00236

PHASE 1 INSPECTION REPORT
NATIONAL DAM INSPECTION PROGRAM

MAY 1979

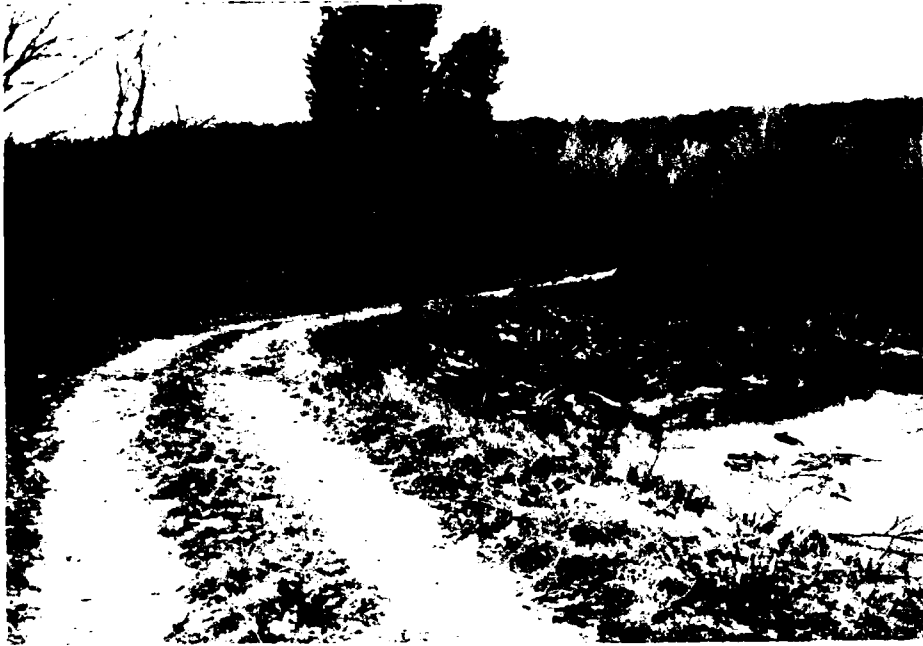
C-3 CREST AND UPSTREAM SLOPE OF MAIN EMBANKMENT AT SPILL-
WAY

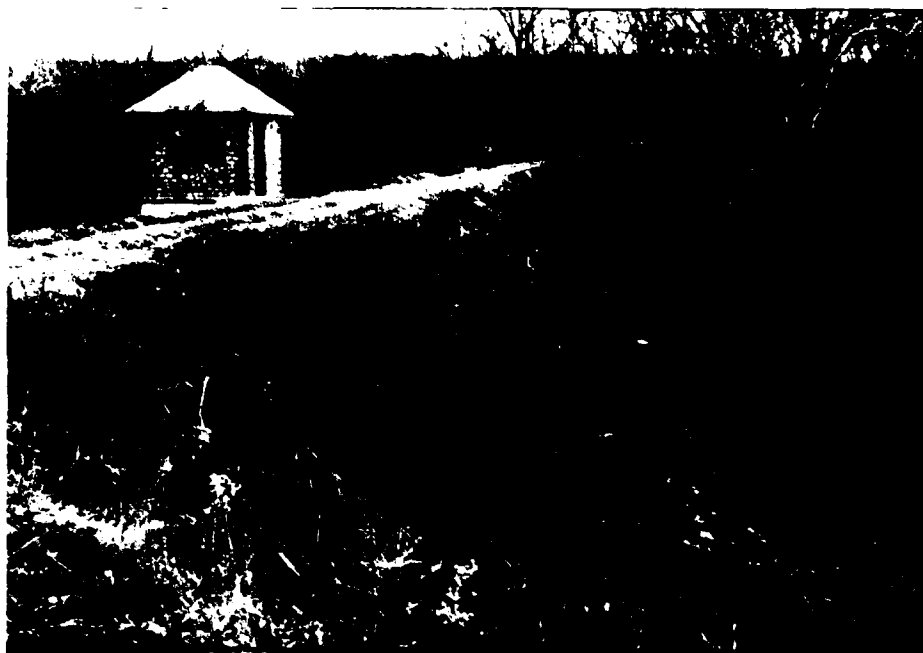
3. Downstream Slope. The downstream slope of the dam is typically 1.5H:1V and is grassed (See Photos C-4,5,6). The slope was covered extensively with vegetation which was being cleared and trimmed at the time of the inspection. On April 9, 1979, the downstream slope has been largely cleared of brush, except for the section to the right of the spillway. A few large trees were found growing within 10 ft. of the toe of the slope. A few isolated erosion gullies were found, similar to the upstream slope. A discharge of flowing water was observed at about Sta. 6+60 approximately 12 ft. from the toe of the slope. The discharge area was about 1 ft. in diameter. The discharge contained trace amounts of sand and freshly deposited sand was found surrounding the area. Representatives of the Owner and plans indicate a toe drain outlet is located in this area and the discharge may be associated with the toe drain outlet buried below the ground surface; however, no direct evidence of the existence of a drain outlet was visible in the field.

C-4 DOWNSTREAM SLOPE OF MAIN EMBANKMENT - LOOKING FROM
LEFT ABUTMENT

C-5 DOWNSTREAM SLOPE OF MAIN EMBANKMENT AT GATEHOUSE

C-6 TYPICAL BRUSH OVERGROWTH ON DOWNSTREAM SLOPE OF MAIN EMBANKMENT

Trees and shrubs on the upstream and downstream slopes of the embankments can create future seepage problems. The tree roots provide seepage paths for water if allowed to grow. Uprooting of large trees can also cause serious "piping" problems by creating pathways through the embankments. An area should be cleared below the toe of the dam for approximately 30 feet in order to allow monitoring of seepage or discharges from the toe drains.
